TEST OF TANDEM PONTOONS, 150 - 200  
POUND CAPACITY EACH, PROTOTYPES OF  
25 TON MODEL

4 FEBRUARY 1948

**U. S. NAVY EXPERIMENTAL DIVING UNIT  
NAVAL GUN FACTORY  
WASHINGTON, D. C.**

**Project No. - SRD 1299/48; Priority "A"**

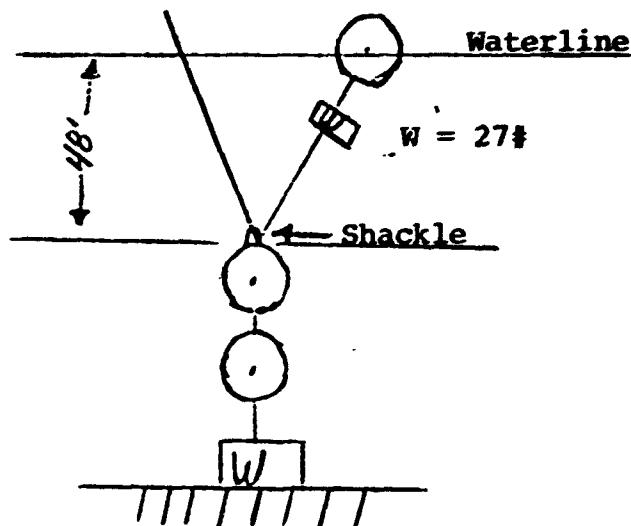
TEST # 9

Test number 9 was made with one of the pontoons being used as an anchor for the standing part of the heaving line. The use of a 37 pound weight was necessary to keep it stable under no load conditions. The first lift was made with some difficulty. The standing and running parts of the line together with the air hose were badly snarled up. It was also evident that the bottom pontoon did not get enough air. The second lift was more successful. This time, the anchor pontoon was kept clear of the heaving line.

The above must be done because when the weight leaves the bottom, the anchor pontoon, the weights, the two lifting pontoons and the heaving line will tend to hang in a straight line, causing them to get snarled up.

Upon surfacing, the anchor pontoon was upset by the rising pontoons and lost its air. It is obvious that this system cannot be used to bring a load to the surface.

Line used was 21 thread. Anchor pontoon with 27 lb. weight. Lifted off bottom about 15 ft. by three men. Rest of lift made by winch. When surfaced, anchor pontoon air was spilled. Hose and line badly snarled with about 4 turns. Shackle used for fair lead on top of pontoon. Bottom pontoon evidently did not get air.

When one of the pontoons is used as an anchor, it must be kept free of the heaving line to prevent snarling. This system can be used only for partial lifts. Loads cannot be brought near the surface because the lifting pontoons will upset the anchor pontoon. Also as the anchor pontoon approaches the lifting pontoons, the angle must increase between the heaving line and the standing line leading to the anchor pontoon. The heaving force must also increase with this angle.
